# 船用淨油機 維修保養攻略

# Separator

## -Introduction & Design

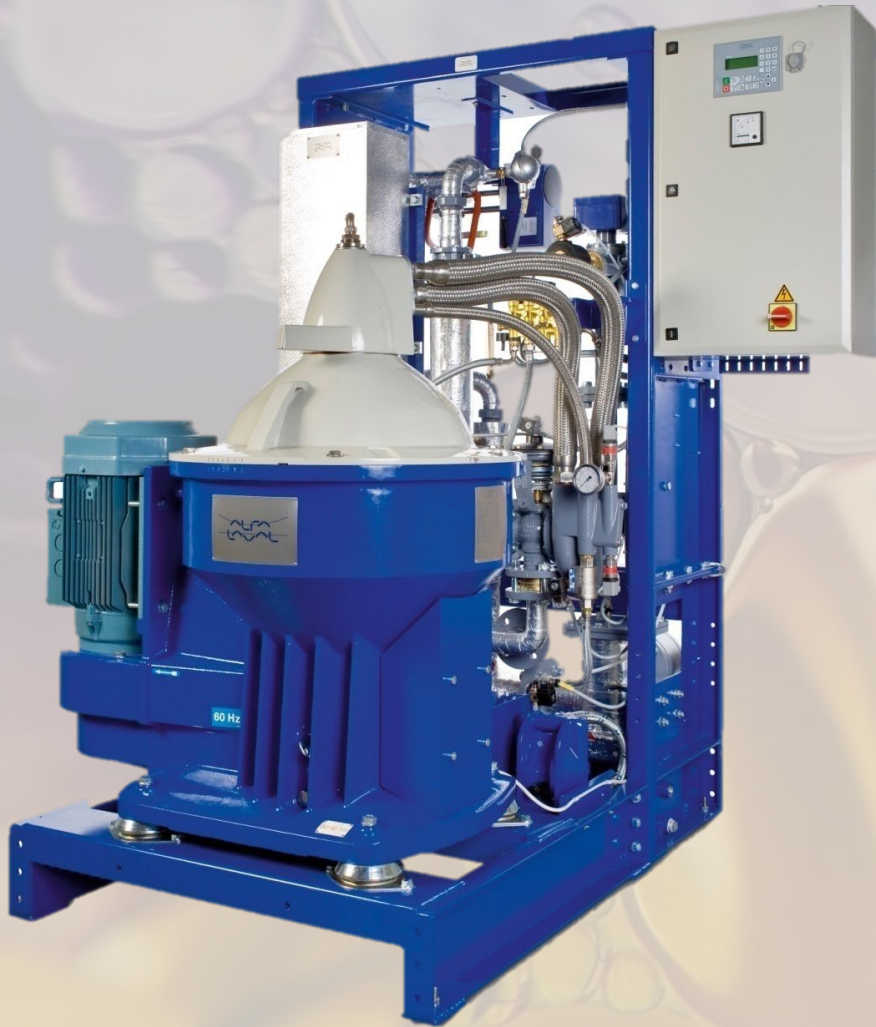
- For hard-to-clean heavy fuel oils that vary both in density and in the type of impurities
- Application:  
Distillate fuels; Biofuels (FAME, HVO); Lubricating oils
- Based on ALCAP technology
  - **A**lfa
  - **L**aval
  - **C**larify
  - **A**nd
  - **P**urify

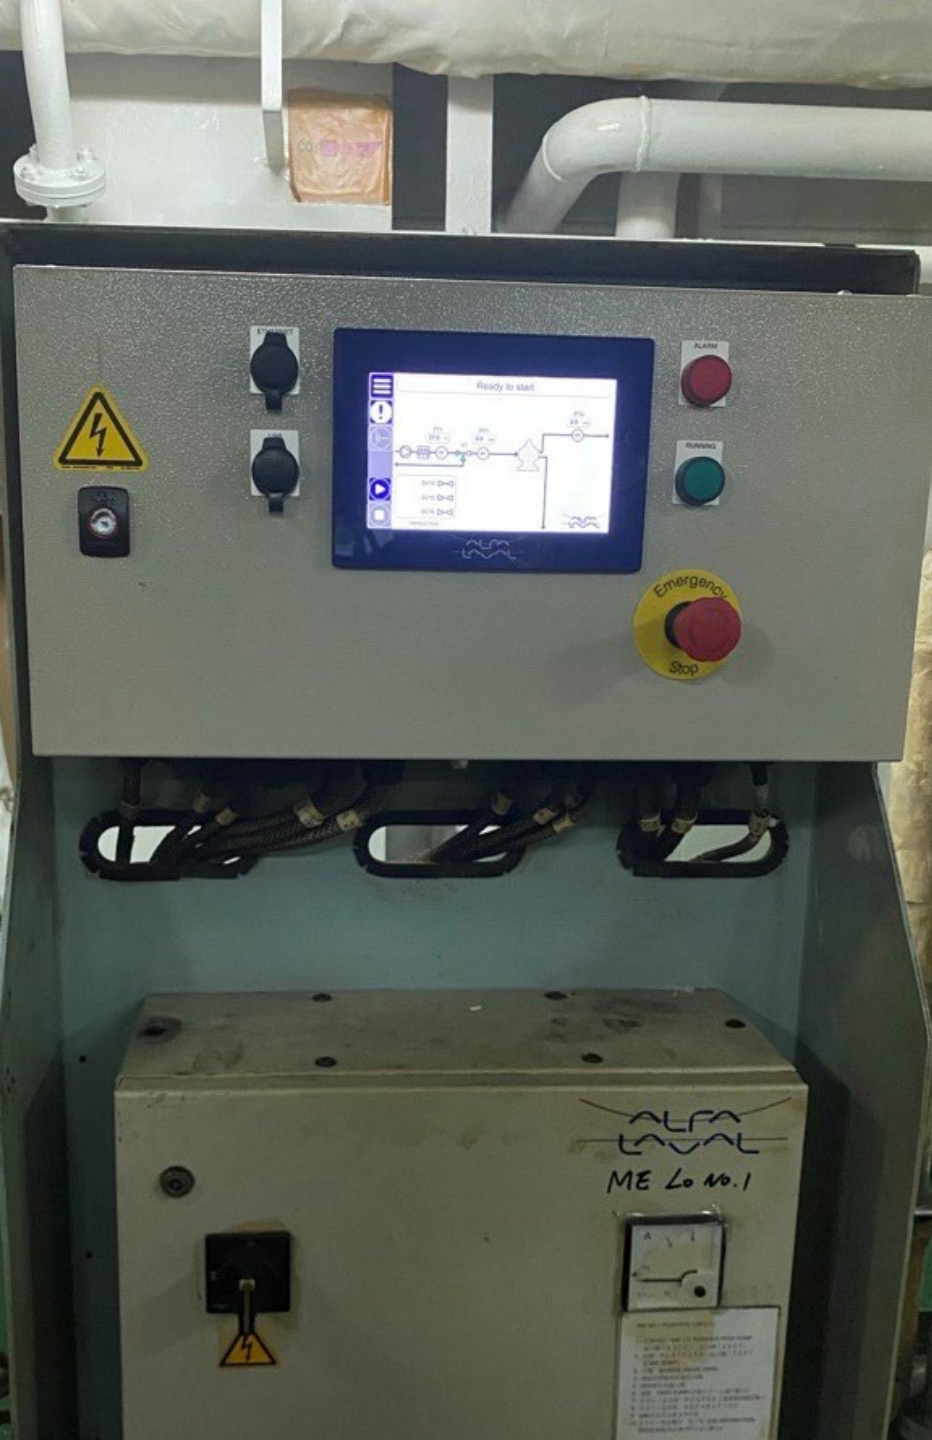
# EPC70 upgraded50

- State of the art control system with latest generation of components
- Available spare parts
- Reduced cost of spare parts (I/O card instead of complete electronic board)
- Easier operation & troubleshooting (touchscreen, I/O card LEDs, etc.)
- Future proof (Connectivity, software upgrade, etc.)
- Cost-effective solution!

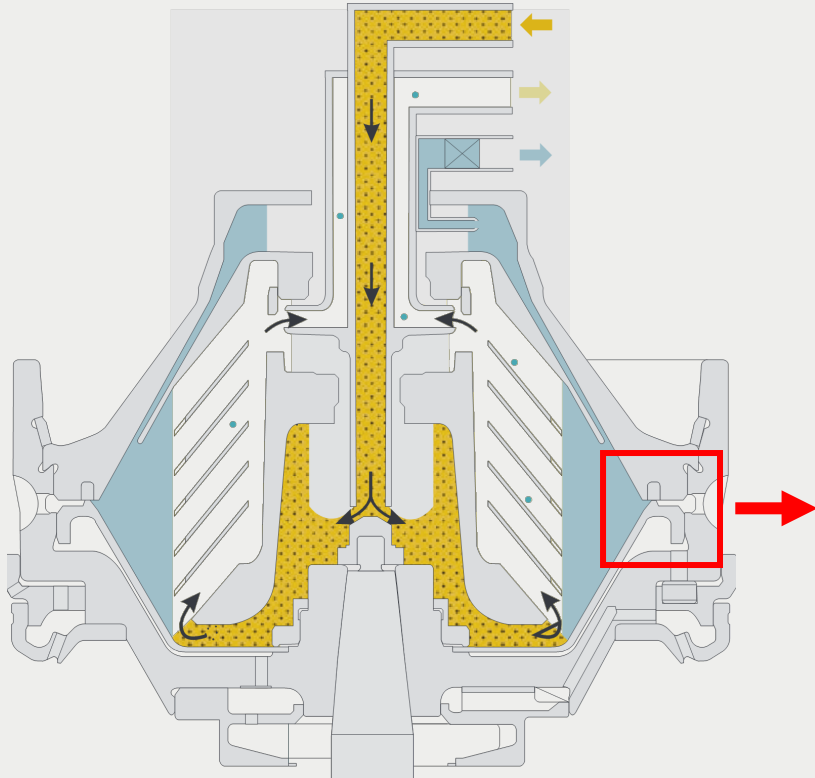
# A51

## Oil Backpressure PT4 Low

- i. Decreased throughput
- ii. Regulating valve open too much
- iii. Change over valve V1 in recirculation position
- iv. Strainer and piping in the operating water supply is clogged
- v. Too little or no water in the operating water
- vi. Hoses between the supply valves and separator are incorrectly fitted
- vii. Nozzle in bowl body clogged. Rectangular ring in discharge slide is defective
- viii. Valve plugs are defective
- ix. Supply valves SV15 and SV 16 are leaking

- i. Check feed pump and adjust flow
  - ii. Adjust back pressure valve
  - iii. Check air pressure, solenoid valve SV1 and output from EPC
  - iv. Clean the strainer and check the and check the whole system fore limestone deposits
  - v. Measure the water flow in the three hoses from the water block and compare with correct values
  - vi. Fit hoses correctly
  - vii. Clean the nozzle
  - viii. Renew the rectangular ring
  - ix. Renew all plugs
  - x. Rectify the leak
- ( Service Kit Recommended)

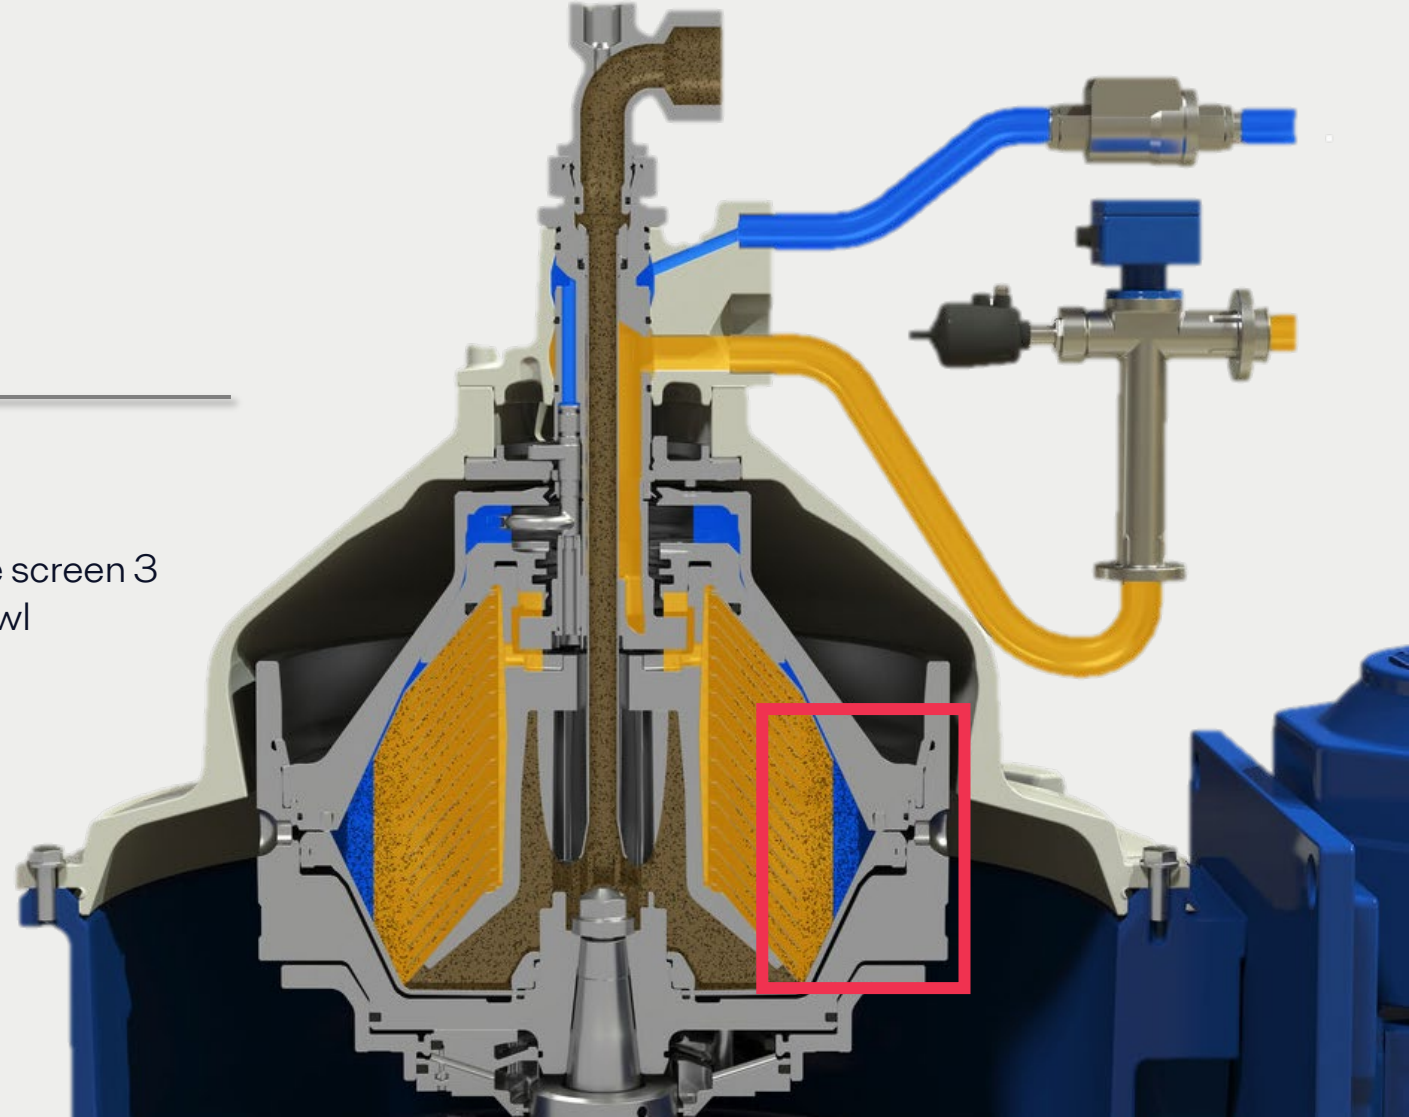
# A131

## Sludge in Bowl

- i. Too much sludge in bowl

- i. Wait until STAND STILL is indicated
- ii. Investigate cause and remedy
- iii. Reboot the system (Press 'yes' on the screen 3 times in a row ) after cleaning the bowl

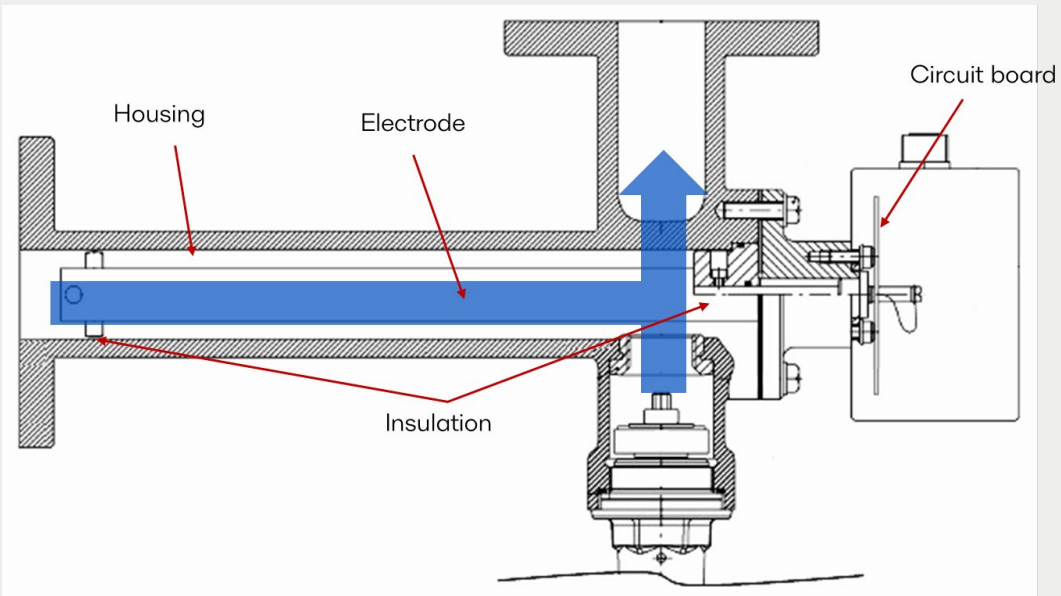
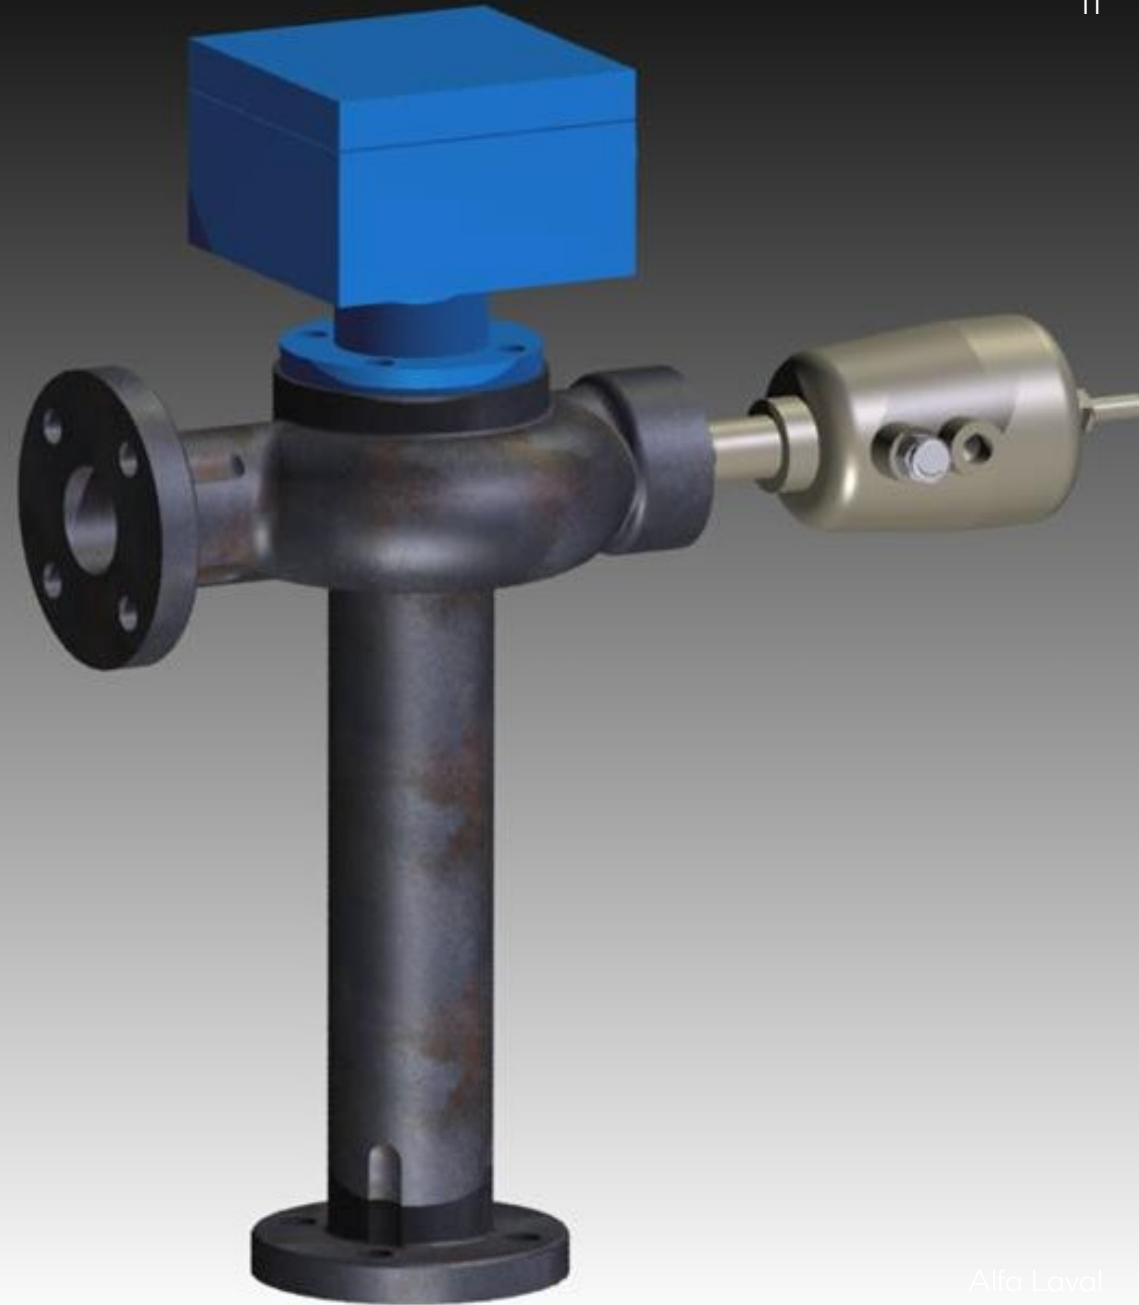
# A83

## Transducer No Response

**Why** MT60 test failure

**What to do** Check water supply & SV10
